Evaluation of heat straightening repair field application on damaged steel girder bridges

The heat straightening repair project on Allisonville road, crossing over I-465 eastbound near Indianapolis, was visited. One of the heat straightening companies conducted heat straightening repair on the east-end girder (Eastbound) damaged by an over-height truck as shown in Fig. 1. The damaged part of the steel girder had previously experienced another damage-repair process before this heat straightening repair. Two eastbound lanes on I-465 were blocked for the repair process during nighttime work procedures.

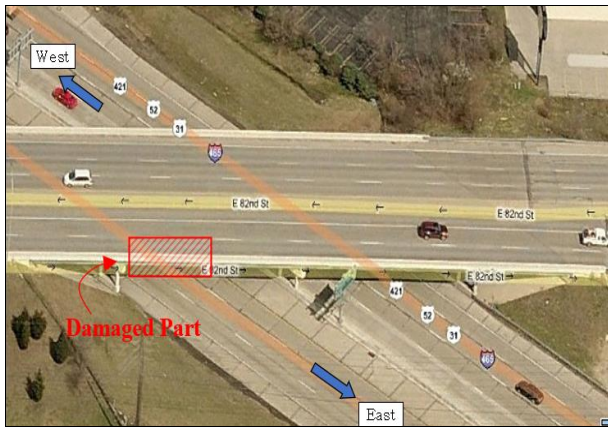
Fig 1: Damaged girder location

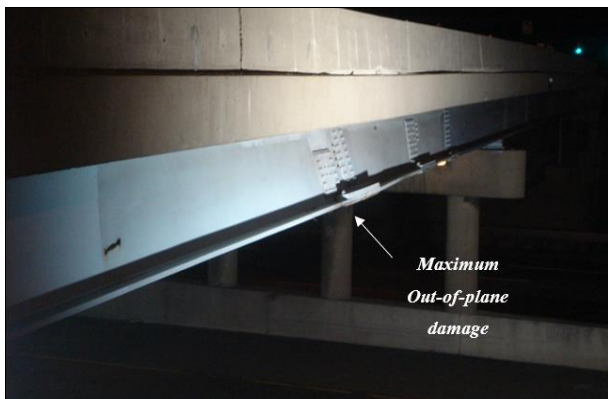
As shown in Fig. 2, the east-end composite beam was hit by an over-height truck at 37 ft. from the south abutment and various types of damages were found around the impact point. These damages included a 6 in. out-of-plane displacement (Combined with distortion) of the bottom flange, formation of the web yield line, and the girder-to-diaphragm connection failure (Including bolt fracture and bearing shear failure of the crossbeam).

Fig 2: Damage on Allisonville Road Bridge

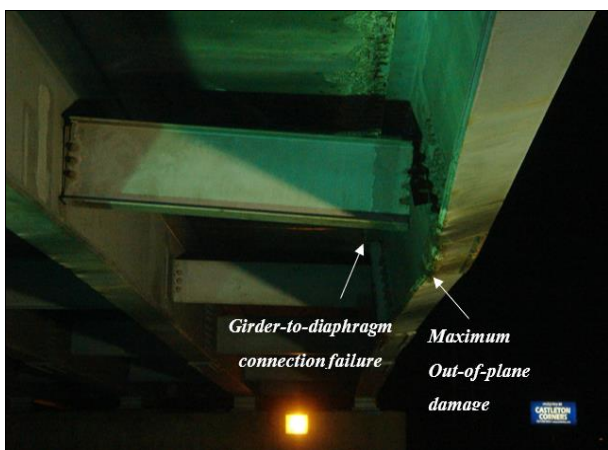
Fig 3: Close-up view of damaged region

The maximum out-of-plane damage occurred at the location with an additional cover plate, which was added in the previous damage-repair process. This is seen more clearly in Fig. 3. Bearing shear failure that occurred in the end connection of one diaphragm is also shown in Fig. 3. Yield lines also formed in the girder web close to the concrete slab following the girder direction.

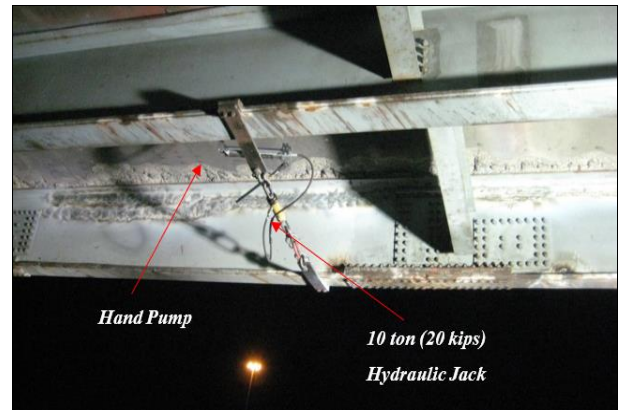
Fig 4: Hydraulic jack system for restraining force

Fig. 4 shows a hydraulic jack system installed by heat straightening repair technicians. They used a 10-ton (20 kips) jack with a hydraulic hand pump to provide a restraining force prior to heating cycles. However, no pressure gages were attached to the system. They just assumed that the applied restraining force with the no-gauged hand pump was close to 10 kips.

At the site, applied restraining forces were not measured. FHWA heat straightening guideline strongly emphasizes that the restraining force must be kept below 50% of plastic moment force. This is done to manage the stress caused by the restraining force during heat straightening.

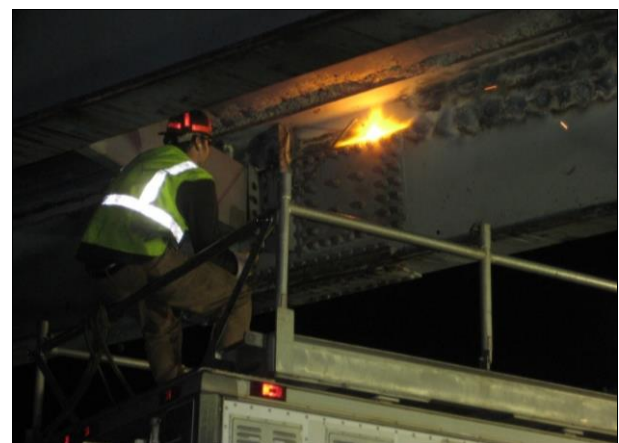
An oxygen-propylene torch was used for the heating process. Initially, line heats were applied on the web of the girder close to the concrete slab. Fig. 5 shows the line heat process being applied by a technician. After the line heat, Vee heats were applied on several damaged points of the beam as shown in Fig. 6. As seen in Fig. 6, half-depth and full-depth Vee heats were properly applied following the deformed shape of the bottom flange. The Vee angle was computed to be approximately 55°.

Fig 5: Line heat on the web of the girder

The heating temperature was measured by the researchers using an infrared thermometer gun. In most of the heating cycles, technicians reached 1300 °F - 1530 °F as their maximum heating temperatures. These temperatures are higher than 1200 °F, which is the maximum heating temperature recommended by the FHWA heat straightening guidelines.

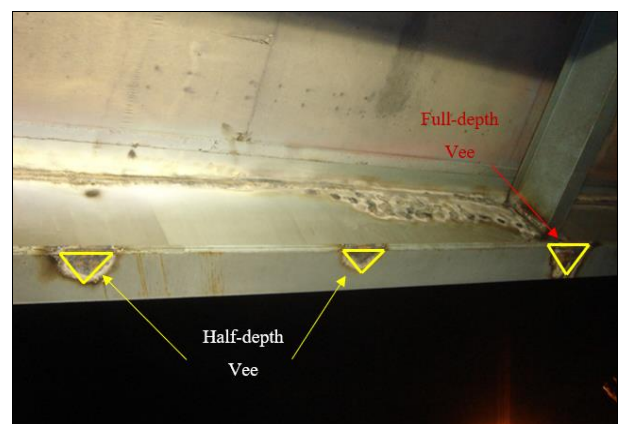
Fig 6: Vee heat locations of the bottom flange
