## Geotechnical investigations into the characteristics of cracking and damage analysis of low rise buildings due to shrink-swell potential of Expansive soils

**Dr. M Selvamsagayaradja and Dr. V Murugaiyan**

### Abstract

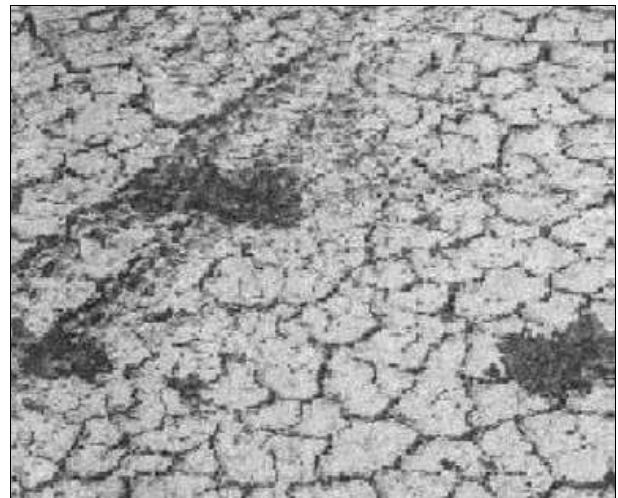
**Fig 1:** Expansive soil with cracks

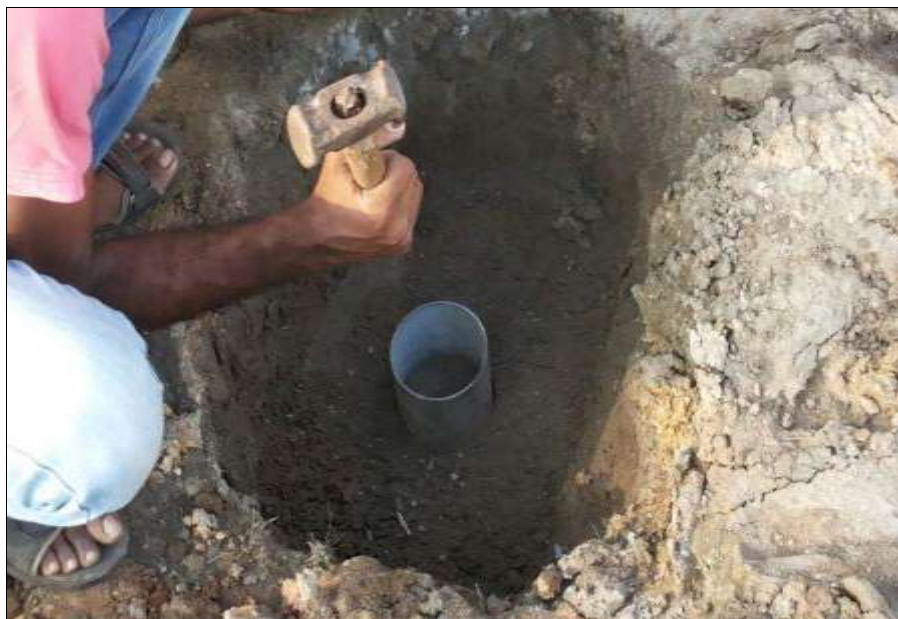
Fig 4: Typical excavation pit Building inspection

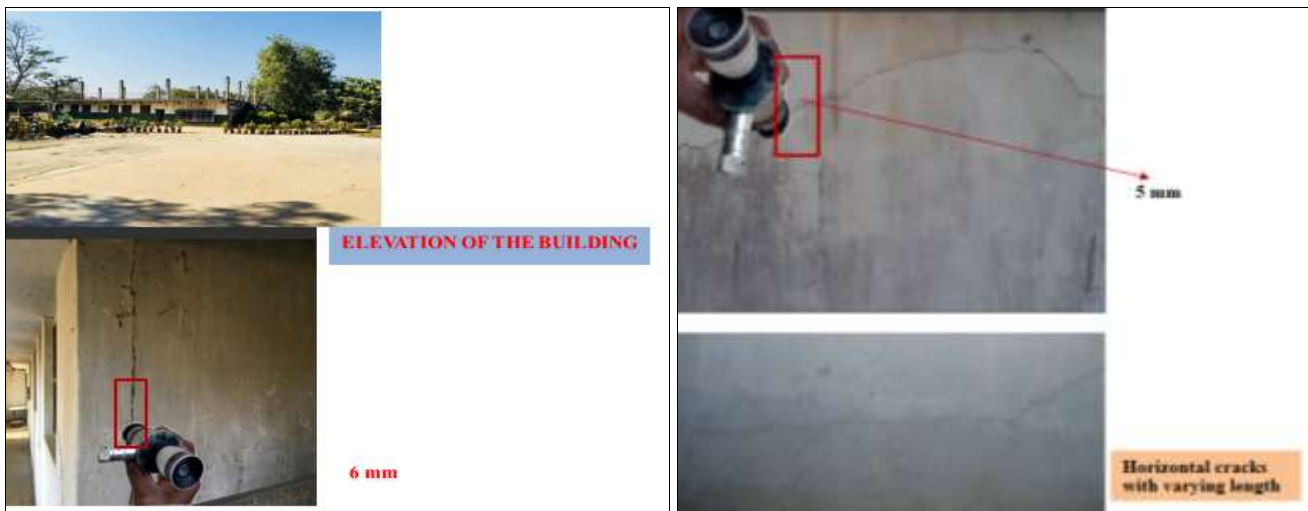
Severe cracks are observed throughout the wall at near the corner of the wall in the vertical direction and the cracks are seen to have been initially developed from the floor towards the height of the wall and also in case study of L7 vertical cracks are identified to separate column and walls. In L3, cracks have developed near the junction of columns and

beams. Diagonal cracks have developed from the corner of window sill towards the wall end and vertical cracks have developed from the lintel towards the floor making the wooden frame distorted, in L6, L7, L8 and L9. Fig. 5 to Fig 14 shows the crack sizes and orientation in the buildings taken for inspection. Details of cracks like length, width and orientations in all the buildings are given in Table 9.

Fig 7: Location L 3, crack separates the wall and column Fig 8 location L 4, longitudinal cracks in the main wall

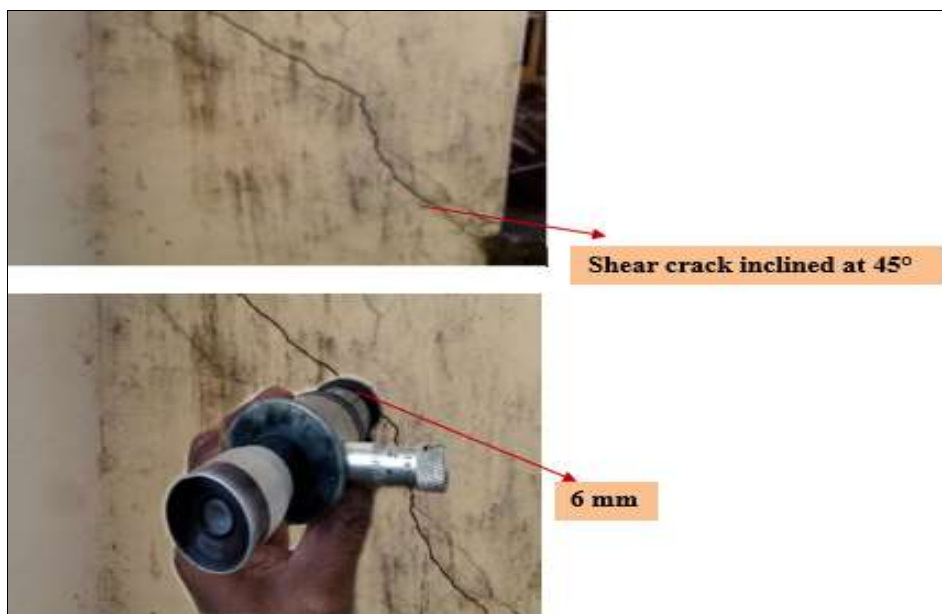
Fig 8: Location L 5, longitudinal Shear crack length >1000 mm, crack width= 6 mm.

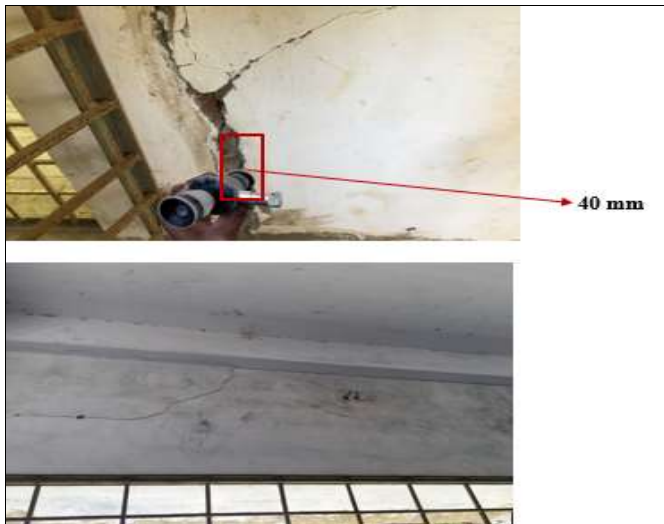
**Fig 9:** location L 6, Wall separation 40 mm.from column

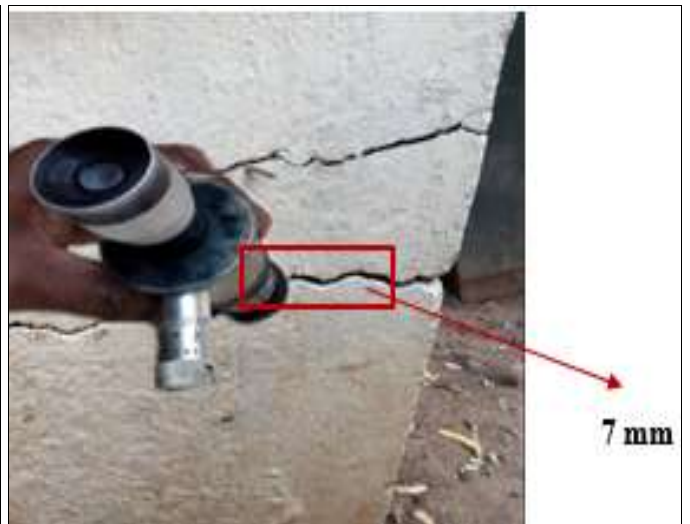
**Fig 10:** Location L 7, Crack width 70 mm

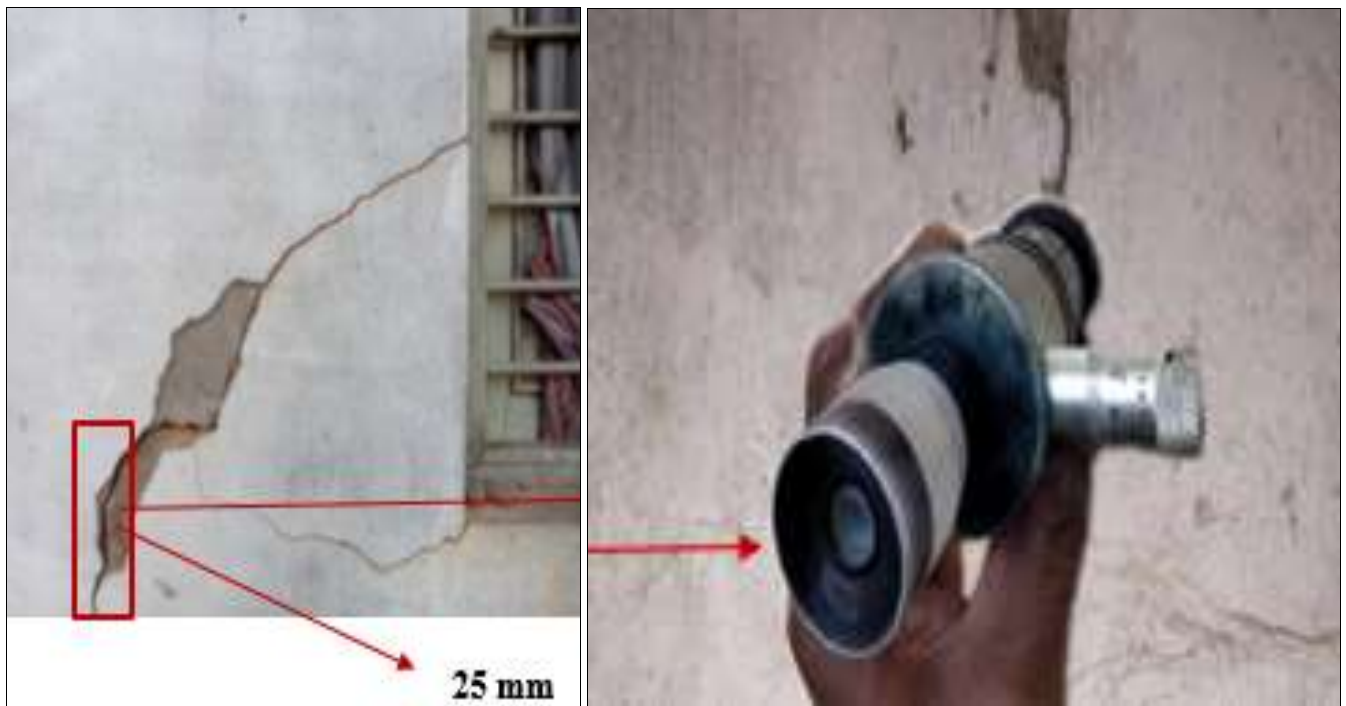
**Fig 11:** Location L 8, Crack width 25 mm and 1000 mm length

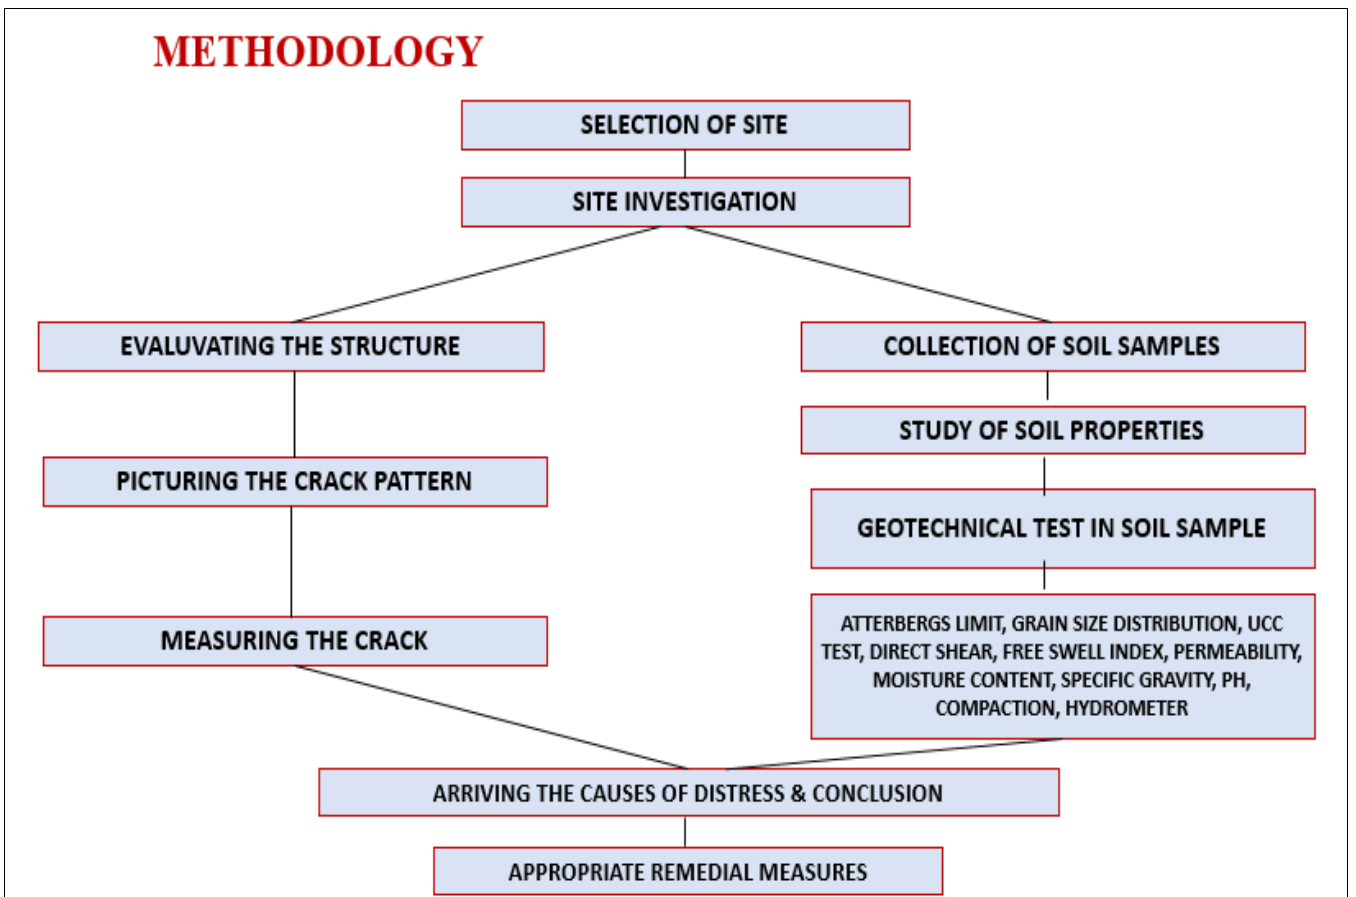
The study was carried out in three stages; reconnaissance survey, building inspection and laboratory testing of soil samples collected from the study areas Fig 15. The reconnaissance survey was aimed at studying the immediate environment of the building in question, and building inspection was carried out to diagnose the distress i.e. Cracks in the buildings based on their location, width, depth, orientation and pattern table. All measurements for the above were based on standard method of building inspection. Soil sample were collected from ten different locations in the near vicinity of buildings at foundation depths ranging from 1-1.5m, and the locations are denoted as L1 to L10. Fig 16. Physical and engineering properties of soil sample were determined adopting relevant IS Codes. The above data is used to interpret the cause of cracks in the buildings.

Fig 14: Methodology chart

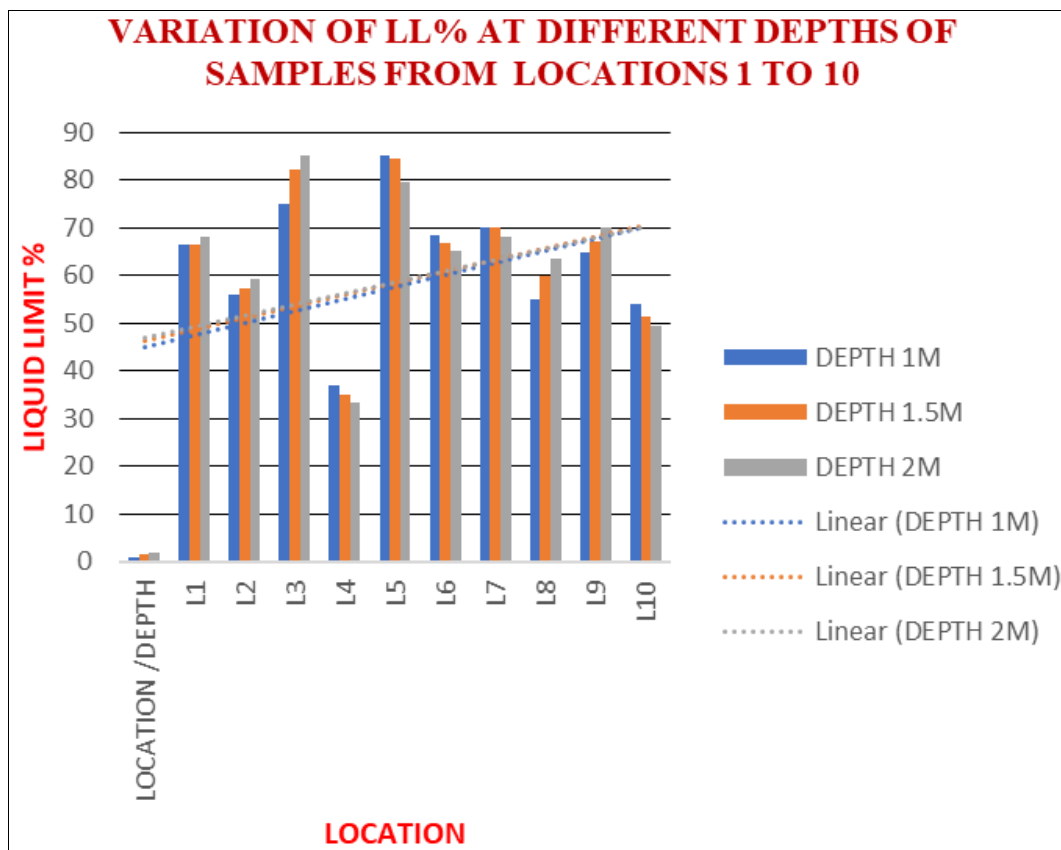
It is seen that the liquid limit (LL) of soil samples in L1 to L10 are greater than 50% except L4 which has LL 37% and hence they are classified as 'silt and clays of high compressibility' i.e. 'CH' soil as per IS code. As the LL of soil samples in L4 is in the range of 35-50, they are classified as silt and clays of medium/intermediate compressibility i.e. 'CI' soil.

Fig 17: LL% of samples from locations L1 to L10

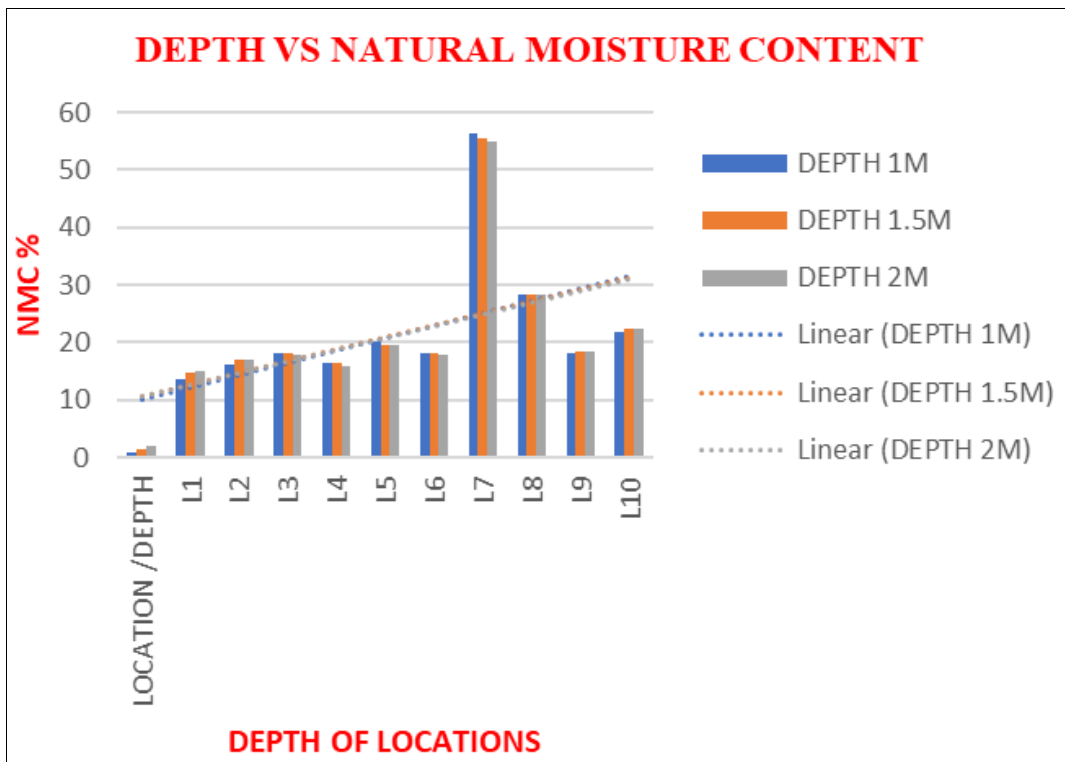
Further, it is seen that the natural moisture content in locations 1 to 6 and 9 to 10 is less than half the liquid limit of the soil specimens in the locations. This shows that the clay layer has undergone significant desiccation, this responsible for causing distress in buildings in these locations. On the other hand, due to constant water logging the natural moisture content is on the higher side and that is reasonable for causing distress in the building in location-7 and 8.

Fig 19: Variation of water content with depth.

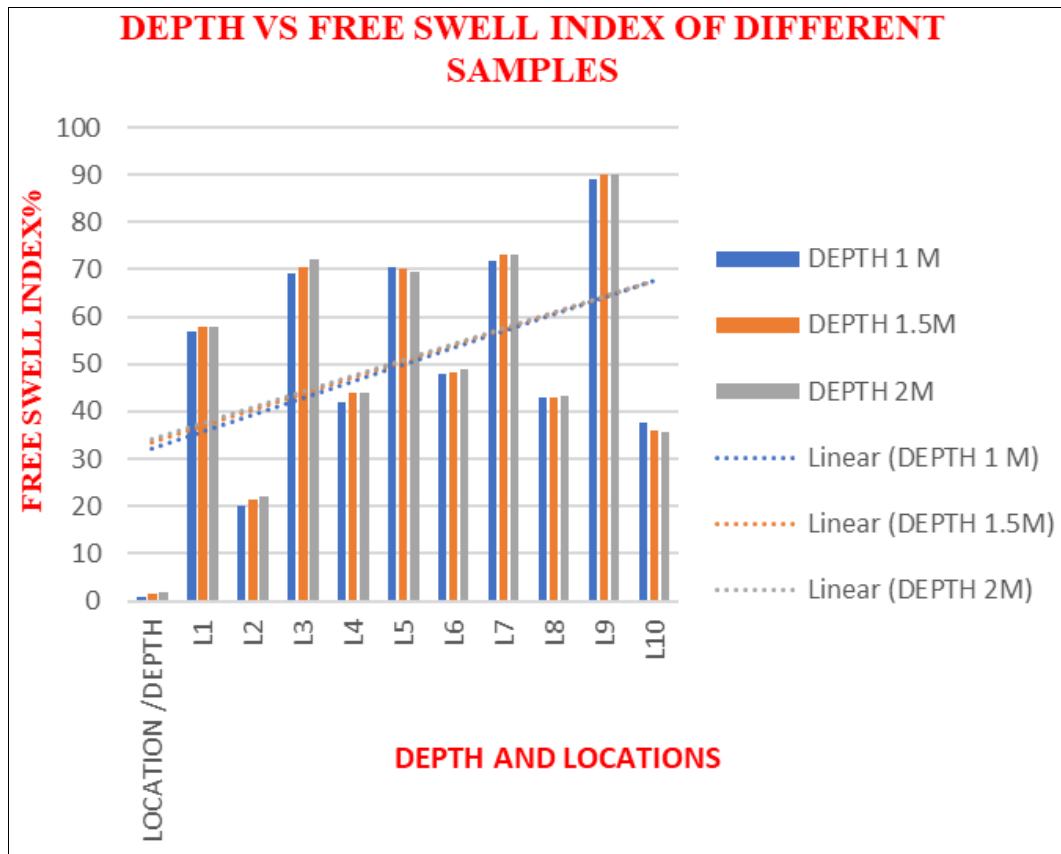
Fig 20: Percent Free swell versus depth for all soil specimens from different locations of various depth
