**Dr. SZS Tabish**  
Professor, Practice,  
Department Civil Engineering,  
IIT, Delhi, India

## Renovation of restroom: A challenging task

### Abstract

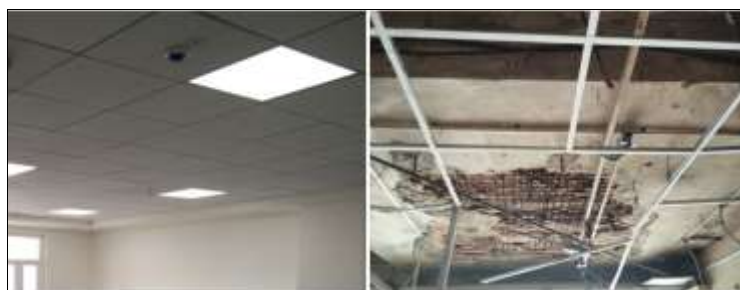
In this particular building, the corridors & surrounding area was covered with false ceiling and restroom was only dismantled and waterproof treatment was carried out inside the sunken slab. After thorough treatment, the sunken floor was filled and fixtures were fixed. But seepage which has percolated and caused rusting to the reinforcement was not checked by removing the false ceiling below the slab. On the complaint of peeling of the ceiling plaster, the false ceiling was removed and it was observed that bottom side of the sunken slab, which was covered by the false ceiling, was rusted as shown in Figure 3 below. It is advisable that whenever renovation of an existing restroom is carried out the bottom side of the sunken slab shall be checked by removing the false ceiling and structural strength of the nearby beams and columns be assessed.

**Fig 3:** Sunken slab with false ceiling and without false ceiling
