# International Journal of Civil Engineering and Architecture Engineering

## Geotechnical perspective of the causes of cracks in building of university campus (Sindh University Jamshoro Sindh Pakistan)

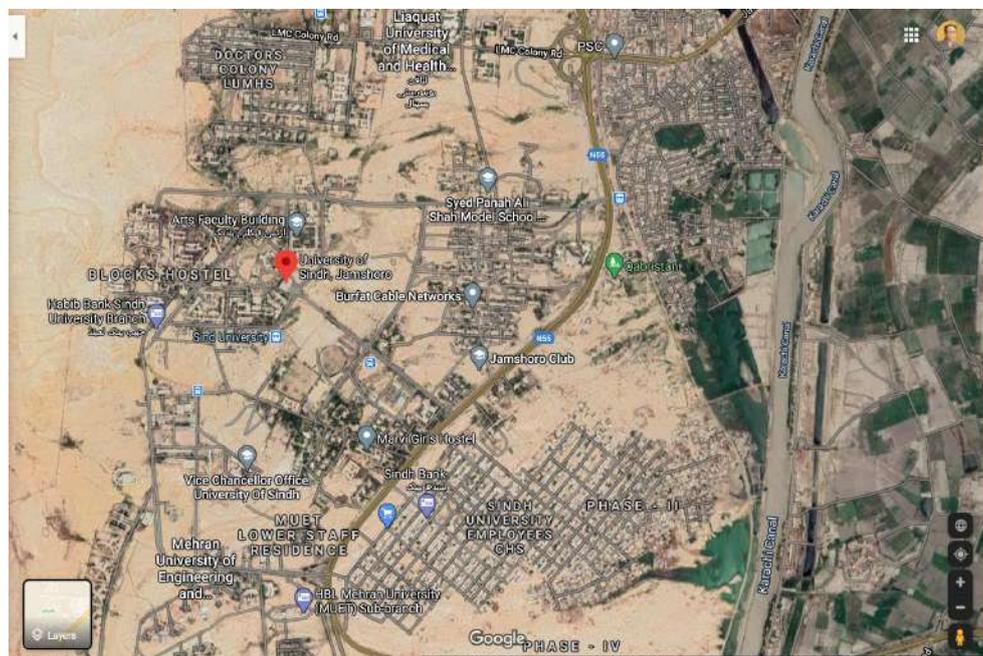
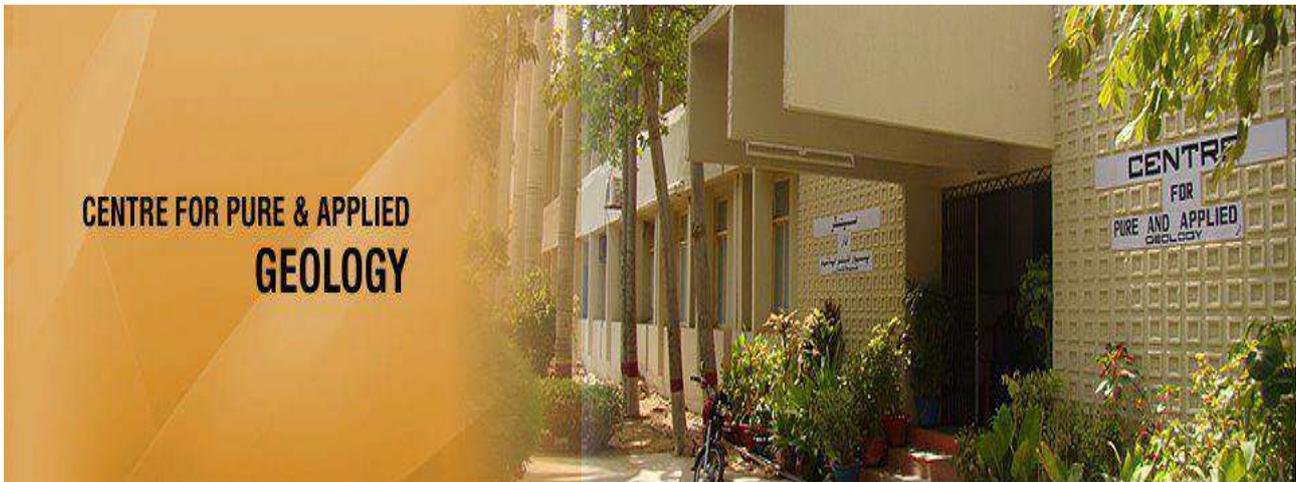
**Fig 1:** Center For Pure & Applied Geology, University Of Sindh Jamshoro Sindh Pakistan (Study Building)

The study was conducted at the Faculty of Natural sciences (various departments) University of Sindh Jamshoro Pakistan. The buildings one storey and housed the Center for pure & Applied Geology, class rooms, admin offices, labs, etc.. This building is located in a flat, low terrain with an upper layer of hard nodular limestone, while the underlying soil is a loose shale with silty clay material. It is located at Latitude 25°25'12.62"N and Longitude 68°15'41.86"E. The Figure 1 depicts the location of the study area. The construction of the building started in 2002 and it was commissioned and handed over to the Faculty in March 27<sup>th</sup>, 2006

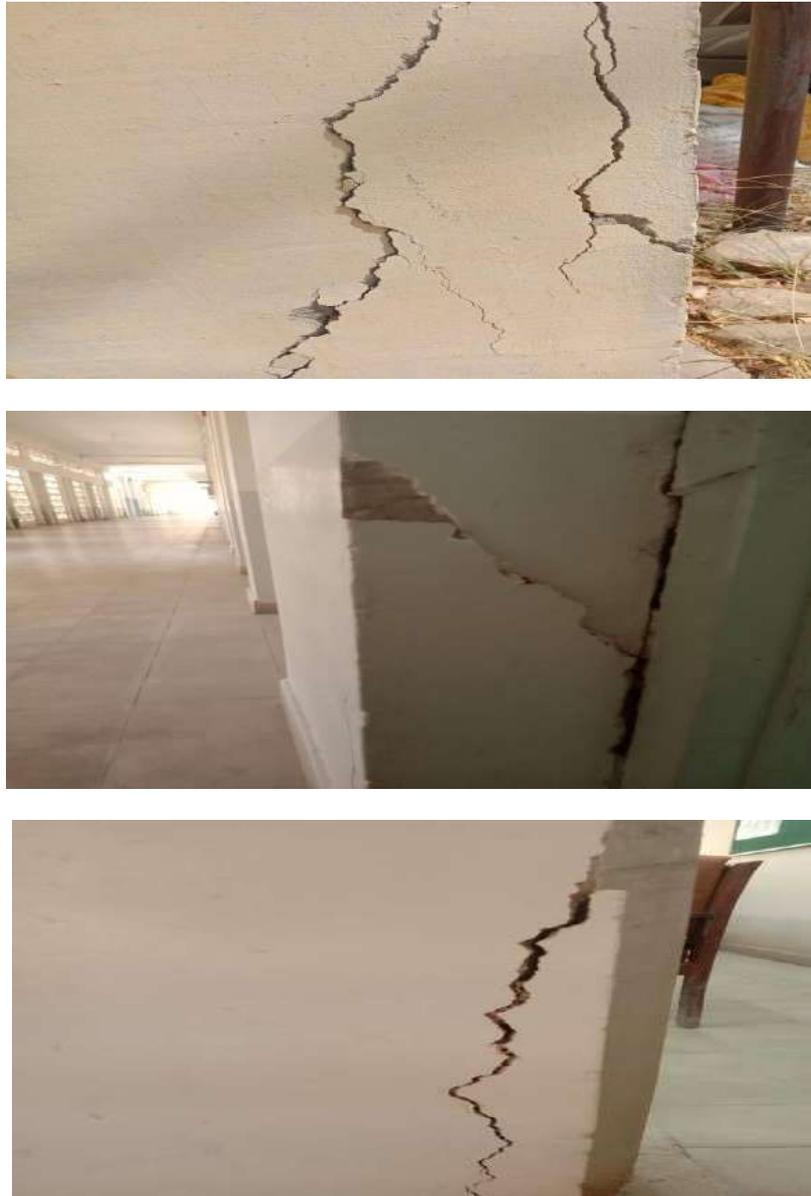
As the second phase of the building inspection was carried out by measuring the width, length and orientation of the cracks. Therefore, starting at the beginning of the study the length and width of the cracks were marked and monitoring activities were continued from time to time to see whether these two parameters increases with a gap of time or not. The monitoring process of the cracks indicated that the cracks in the building are active cracks shown by the appearance of new crack edges during the building inspection. Majority of these cracks are classified as very severe categorized as stability cracks with an average width greater than 20 mm [6] in the foundation walls and greater than the specified 0.3mm on the columns, beams and the staircase slab. This is very alarming when compared with the maximum acceptable value given by Burland and Day (1977) and in BS8110 (1997). These cracks are more dreadful on the left hand side of the building which has more loading compared to the right hand side of the building, same as on the ground floor of the building than on its first floor. These cracks are fastly increasing in depth and width caused by the settlement of the foundation soil and the possible sliding of some parts of the foundation [10]. The horizontal cracks are wide and of constant width throughout their lengths and seem to have occurred at the same time possibly caused by excessive settlement as a result of poorly constructed foundation and poor workmanship. Diagonal cracks have also emerged from the corners of beams pocket, door and windows edges, and the vertical ones were identified. They may be caused by the gradual vertical movement of the foundation and concrete shrinkage. The slab and some of the columns also suffer severe cracks extending through the walls possibly caused by; uneven settlement in the foundation soil putting the building under tension. Figure 2 shows some of these cracks.

**Fig 2:** Cracks showing size and orientations in the building

grown trees near the building which can influence the beginning of the cracks and all the seepage systems within the building area are little lawns and gardens. Therefore, the cracks in the building are caused by ingress of tree roots in the building or because of water penetrating into the ground due to lack of proper natural cracks present in the geological formation sequence.

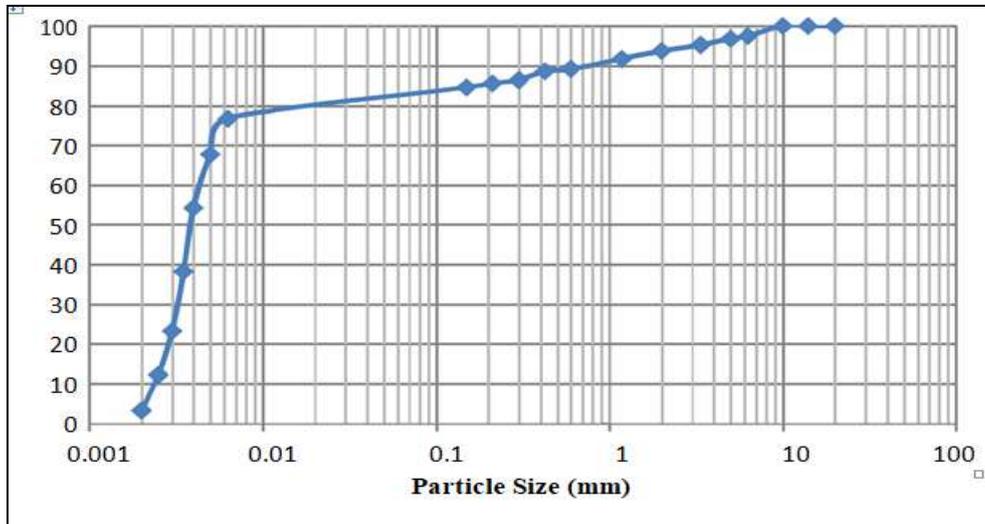
A number of index property tests were conducted on the soil samples collected from the site. The soil classification was the main physical index property of the soils investigated in this study, depends on several factors such as the Atterberg limits, specific gravity and particle size distribution. Figure 3 shows a typical particle size distribution of the soil sample collected from the site. The plasticity index (P I) of the soils was plotted above the A line [1, 2] which is the range of clayey materials. Therefore, based on the British Soil Classification System (BSCS), the soils are classified as clayey soils of intermediate plasticity (CL). The particle size distribution tests indicate that the foundation soil contains a

high percentage of fine material ranging between 78.18% and 85.57% as indicated by the high plastic nature of the soil.

**Fig 3:** Particle size distribution of typical soil sample from the study

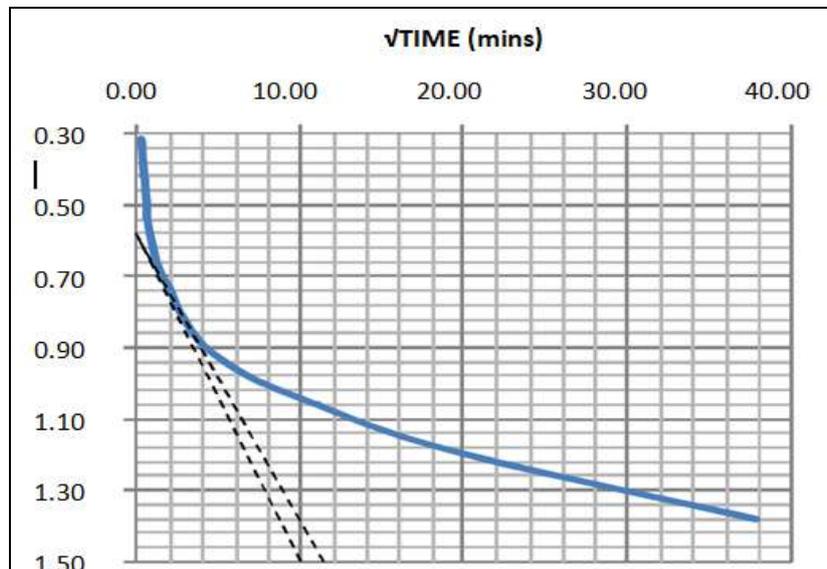
Fig 4: Typical Consolidation test result

Figure 4 shows the coefficient of consolidation was determined using the square root of time method and a typical result of this test. The coefficient of consolidation of the soil lies between the range of  $0.23\text{cm}^2/\text{sec}$  and  $0.34\text{cm}^2/\text{sec}$  which is considered relatively low. This is an indication to the poor hydraulic conductivity of the soil; so the soil will continue to reduce in volume over a long period of time after the rapid settlement and may be several times greater than the immediate settlement<sup>[15, 16]</sup>.
