E-ISSN: 2707-837X  
P-ISSN: 2707-8361  
IJCEAE 2021; 2(1): 07-11  
Received: 04-11-2020  
Accepted: 06-12-2020

Jean Marie Vianney Ntamwiza  
Rwanda Polytechnic / IPRC  
Kigali, Rwanda

## Vetiver walls mixed with banana fiber bags to rehabilitate areas piloting around park under the cycle in Ngororero and landslide prone areas

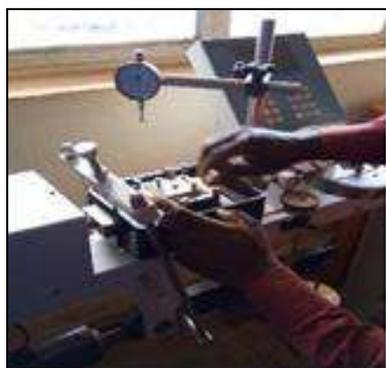
**Fig 2:** Fixing shear box in direct shear device

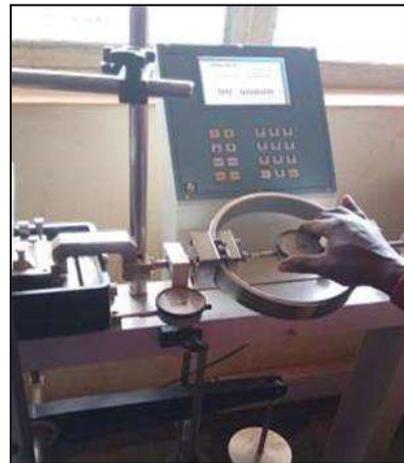
**Fig 3:** Initialize gauges to zero

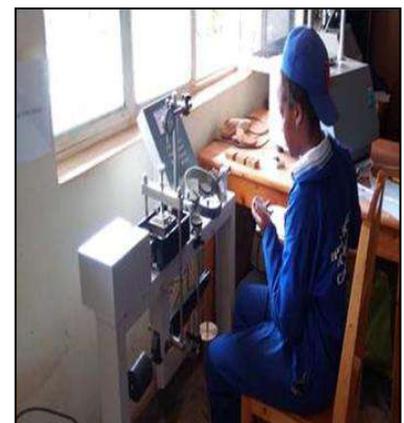
**Fig 4:** Record the readings on the data sheet

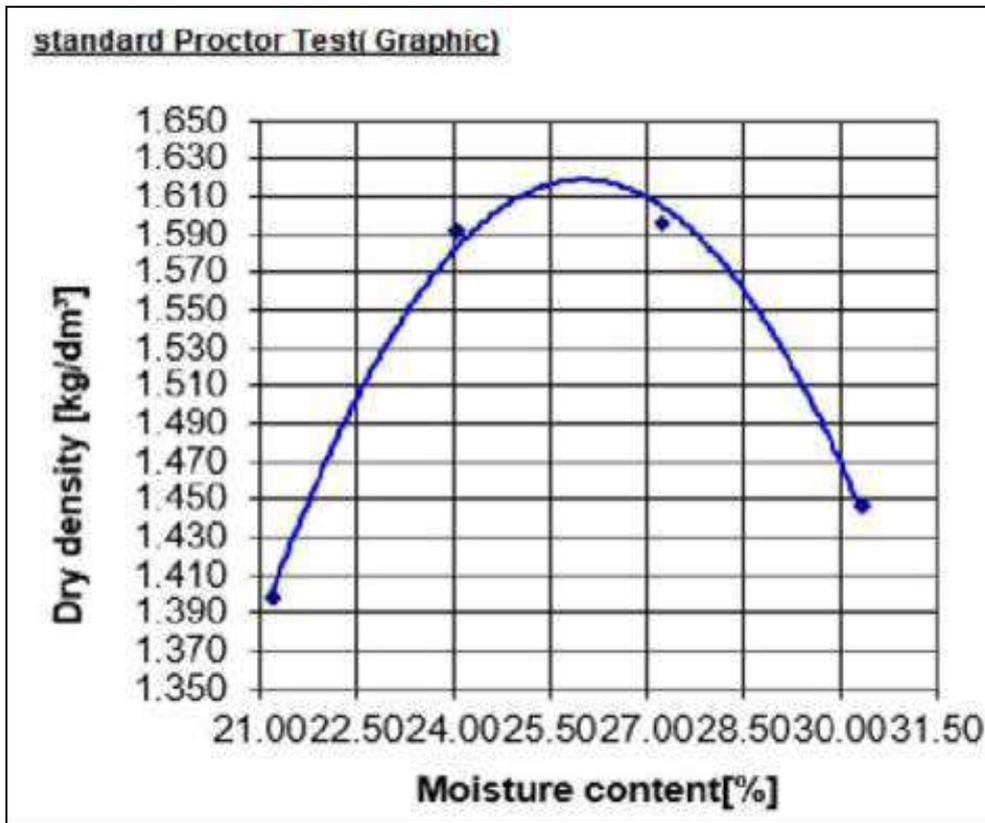
The results of Standard proctor test where moisture contents in mould 1,2 3,4 are 21.19%, 24.04%, 27.23%, and 30.34

respectively and results of Dry density in mould 1, 2,3,4 are 1.4, 1.59, 1.6 and 1.45 respectively, finally M.D.D is 1.60 g/cm<sup>3</sup> and O.M.C: is 27.23%.

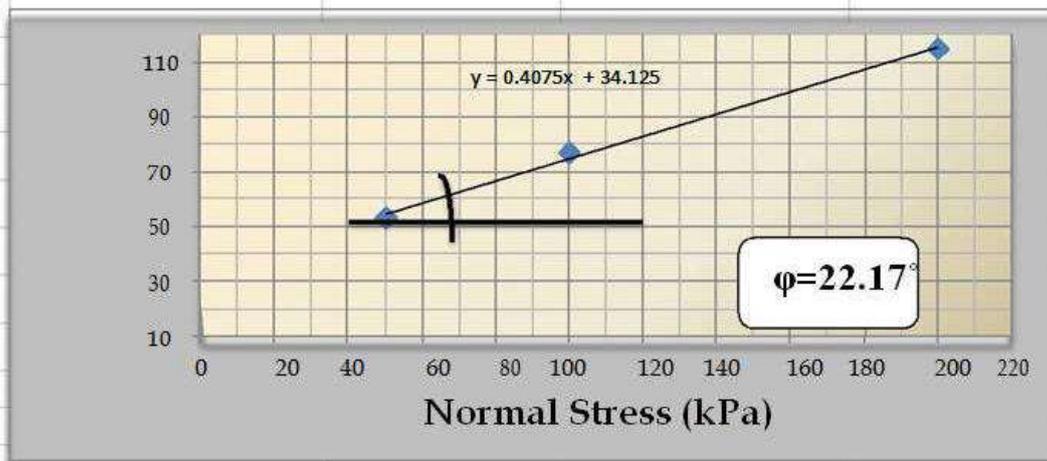
Above results indicate that cohesion is 34.13, angle of

internal friction is 22.17 and slope is 41% in mentioned area.

**Note:** The test carried out based on AST D3080
